PROOF DEPARTMENT
ARMY AIR FORCES PROVING GROUND COMMAND
EGLIN FIELD, FLORIDA

FINAL REPORT

TEST OF T14 FIELD MECHANISMS FOR 20MM GUN AN-M2

Serial No.: 2-43-91 No. of Pages: 5 Date: 23 November 1943
AAF Board Project No. (M-5) 23

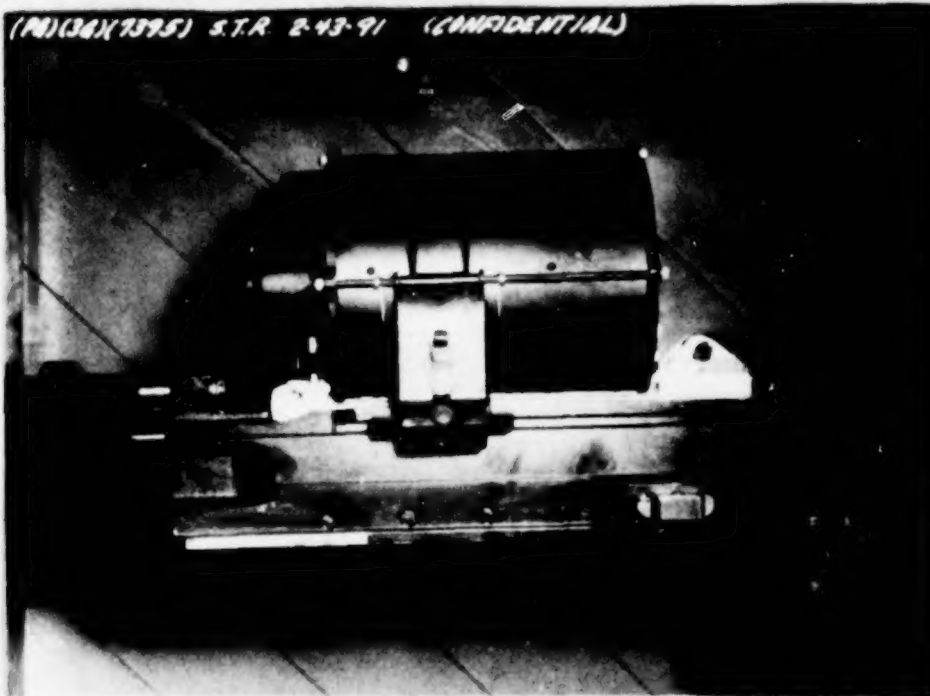
(P)(36)(7395) S.T.R. 2-43-91 (CONFIDENTIAL)

Side view of
Standard AN-M1
feeder.

These two (2) photo-
graphs show the con-
trast in size of the
AN-M1 and T-14
feeders.

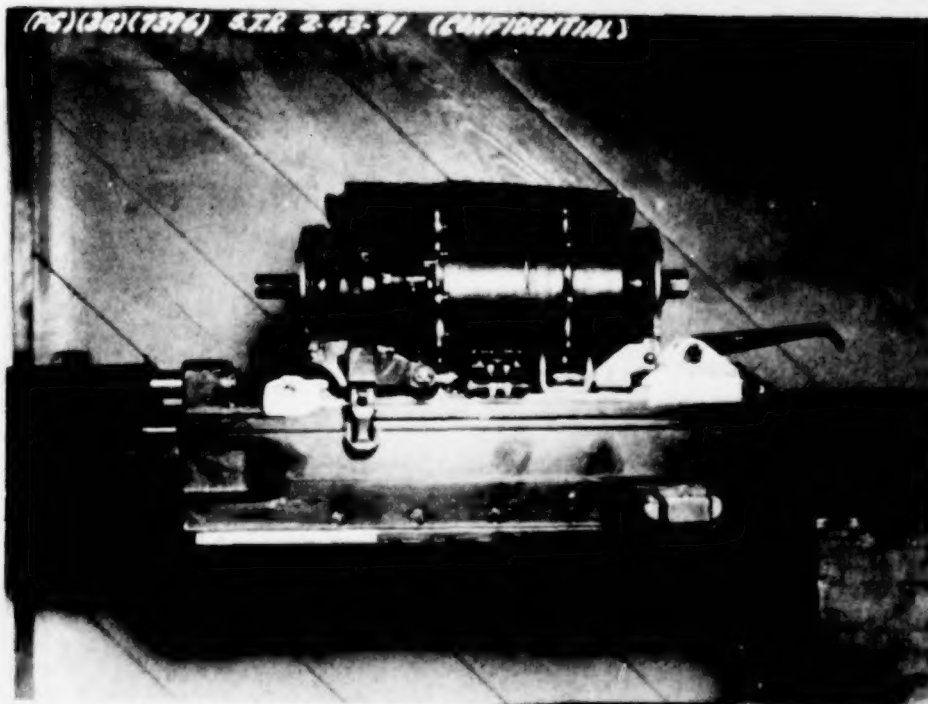
(P)(36)(7396) S.T.R. 2-43-91 (CONFIDENTIAL)

b. Less time is required to train personnel properly to maintain the T14 feed mechanisms for 20mm cannon than is required for the AN-M1 feeders. The T14 feeders are open and expose all of the operating parts; breakages can be seen easily without taking the feeder apart. This type feeder will require less maintenance in actual field conditions. No oiling is necessary and the parts do not burr as easily as in the AN-M1 feeders. Burrs often make it necessary to take the AN-M1 feeders apart and stone the burred parts. The T14 feed is more easily and quickly taken apart and reassembled than the AN-M1 feeder. It is not necessary to take the T14 feeder apart as often as the AN-M1 feeder. The T14 feeders are smaller and easier to install. (See Inclosures 7 and 8.)

Side view of T-14
feeder.

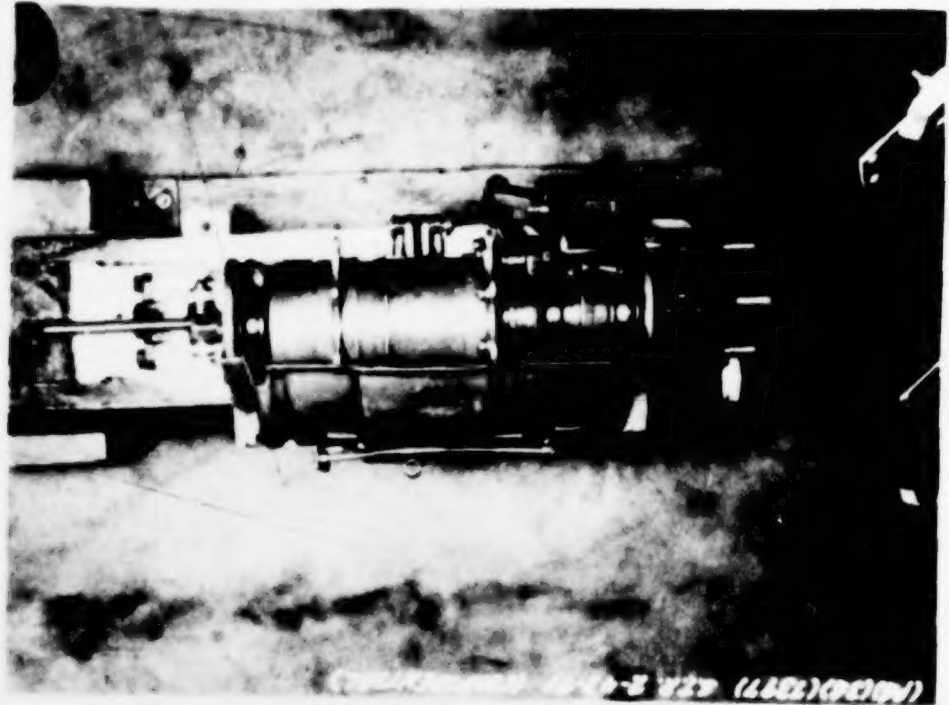
Top view of T-14 feeder.

These two (2) photo-
graphs show the contrast
in size of the AN-M1
and T-14 feeders.
